Storm water measures in Pori

UBC Commission on Energy, Environment and Transportation
Joint Meeting
Gdynia, 17-19 March 2010

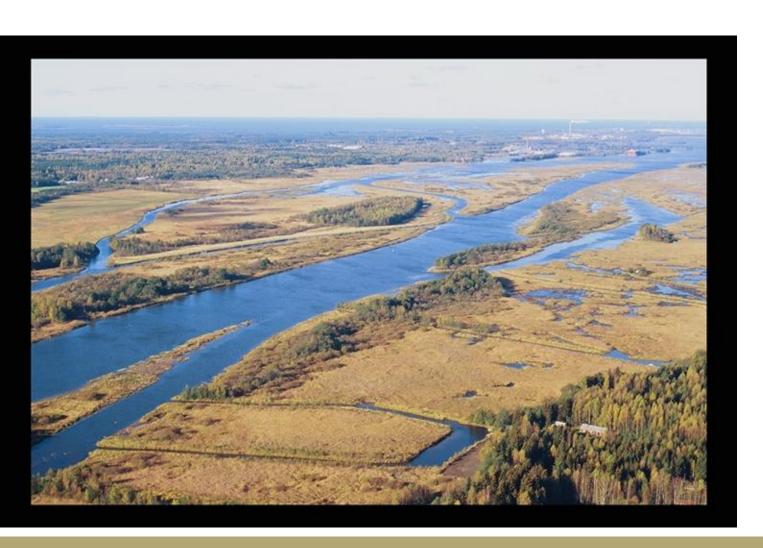
River Kokemäki

- 150 km long
- catchment area27000 km2
- flow on average 340 m3/s
- max flows appr. 900 m3/s
- •Waterway of river covers appr. 10 % of all Finland
- •The waterway is the fifth largest in Finland

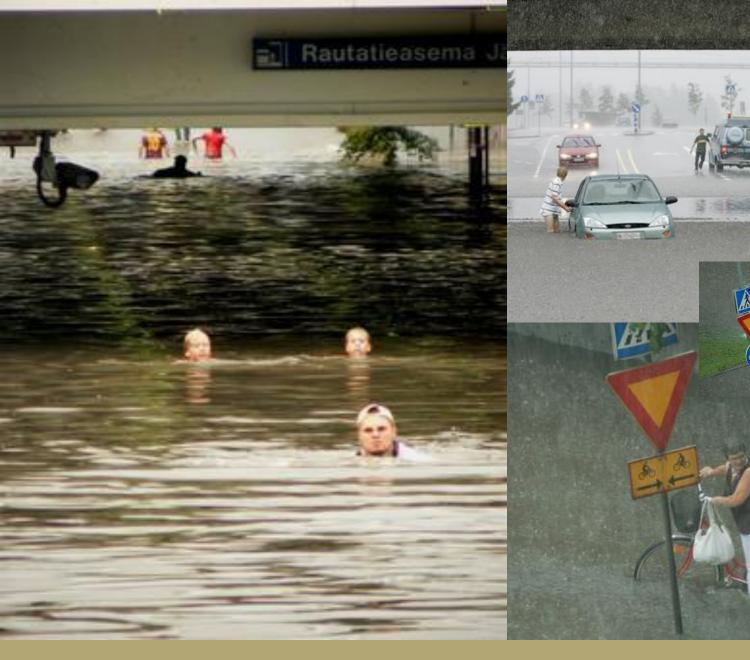
Rescue services had 17 units in use from Pori and neighbourhood. There were over 100 rescue operations of pumping water out of the roads and cellars (red dots on the map).

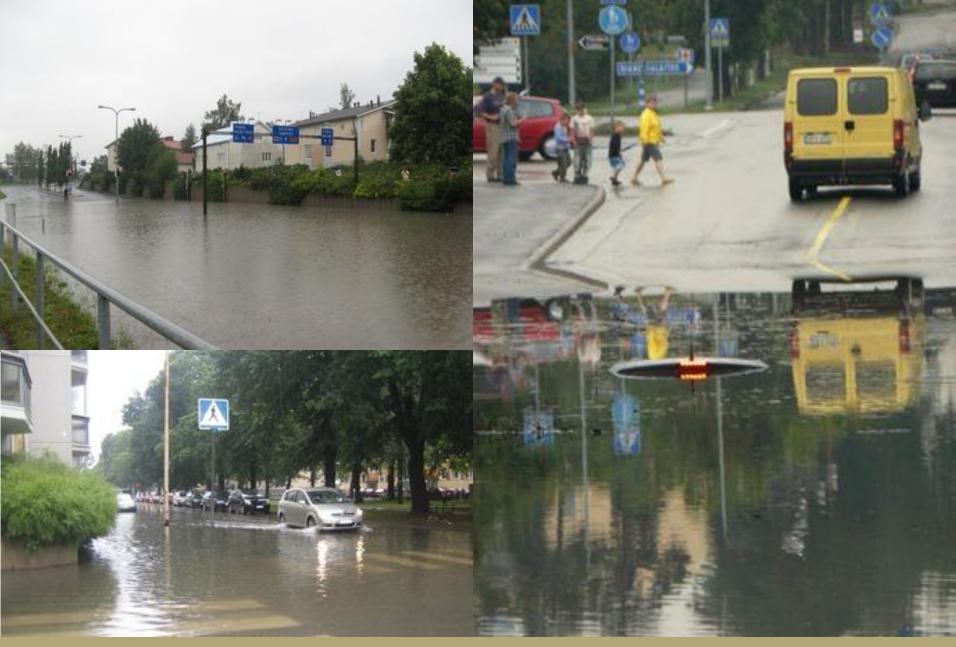
Underpass on Luvianpuistokatu, which is important street leading to the city center. It was filled with water and several cars were stuck under water. Pictures by Janne Lumme

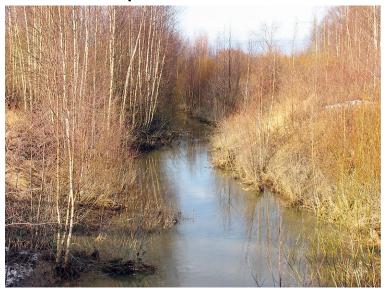
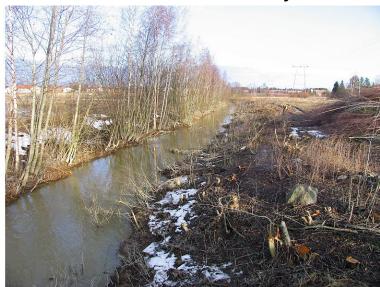
- December 2007 : Suntinoja
- Waterway was cleared of trees and other material blocking water from running (same process is done in many important waterways around the City of Pori)
- Retention pond will be built later to the end of the waterway

The pictures are taken before and after clearing. Jouni Pihlanko

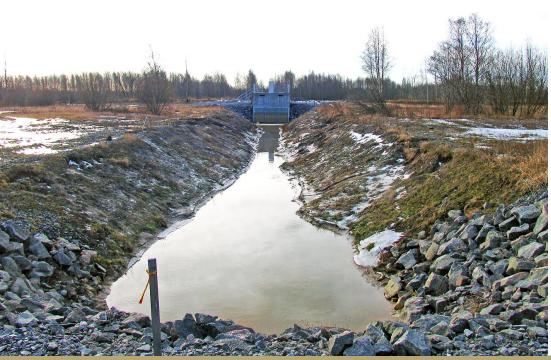
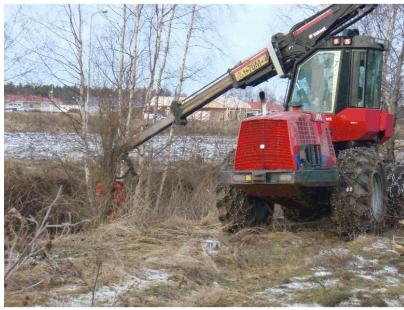
On the left:

New pumping station was built to Isojoenranta. It is part of the drainage system in Northern Pori (Jouni Pihlanko 2008)

On the right:

Clearing of the waterway is undergoing

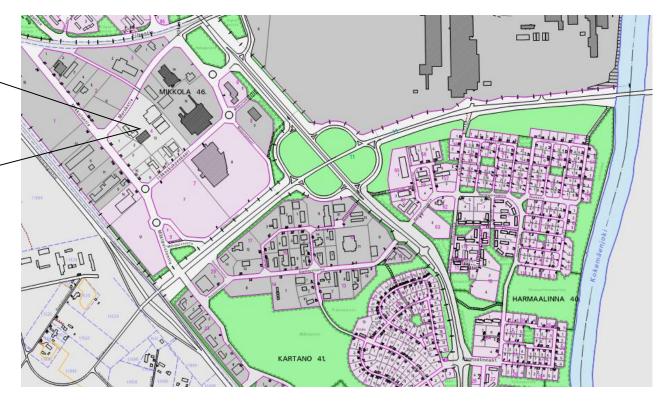
Mikkola:

A lot of commercial and industrial space, an airfield, motorways and a small residential area

Mikkola:

Two reservoirs were built to traffic greeneries.

They hold 8600m³ and 13500m³ of water.

Around them lies appr. 100000m² of buildings and other water resistant structures.

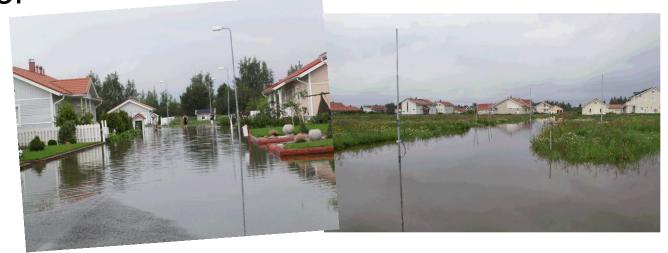
Lotskeri: Turilaanpuisto Water will flow freely on waterways inside the park

- new residential area called Lotskeri suffered from floodwaters in 2007
- Local green area was not built yet, so it was a perfect place to try a new approach: a water element inside the park that would naturally retain water

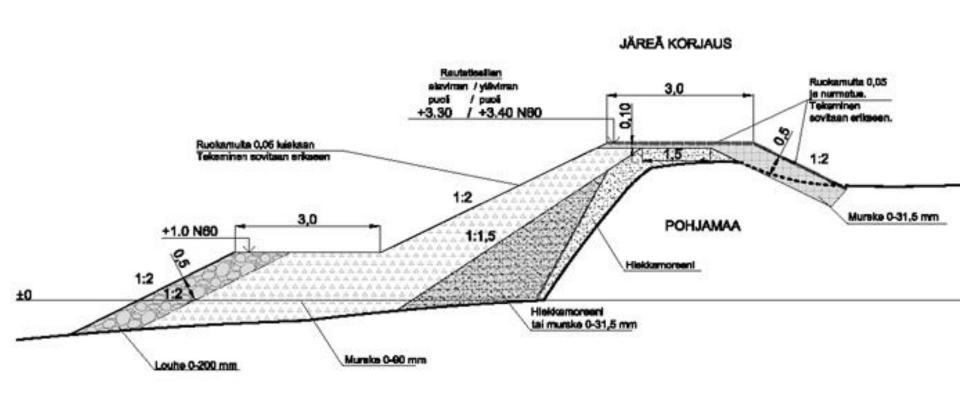
Project 4: strengthening levees:

riverbanks of Kokemäenjoki are typically low, levees add protection against flood damages
